Manhole Inspection Summary

Manhole # S37GG_029MH

Insp Date: **3/21/07 11:18 AM**

Location Address: **1303 PROCTOR ST**

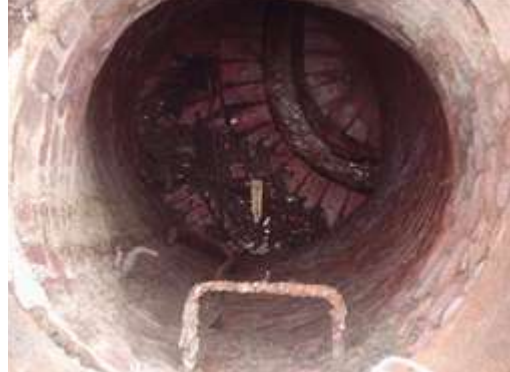
Top View

Corroded and missing steps. Evidence of surcharge - Bench debris.

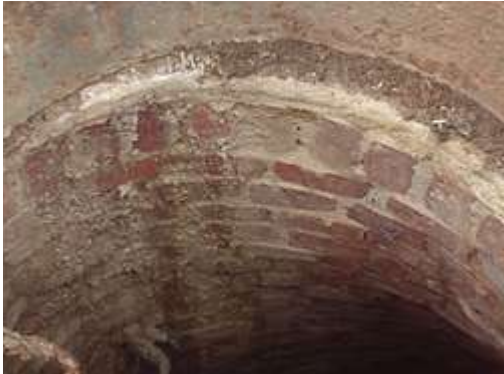
Defect

Frame leaks. Frame offset. Adjustment deterioration and infiltration. Corbel infiltration.

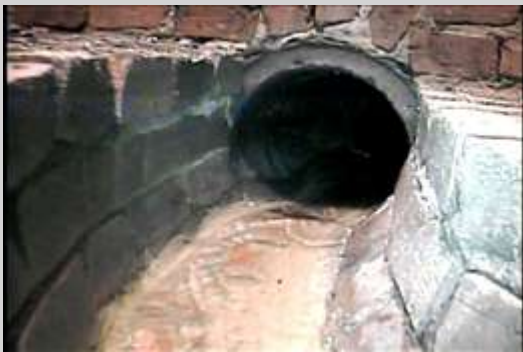
8 in. Circular Gravity Sewer Pipe Out @ 12 O'Clock

Barrel deterioration and infiltration. Channel and Bench deterioration.

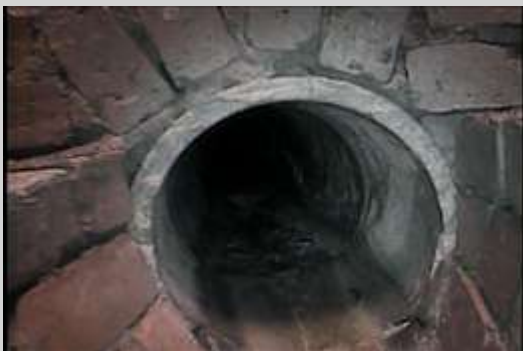
8 in. Circular Gravity Sewer Pipe In @ 3 O'Clock

Barrel deterioration and infiltration. Channel deterioration.
